# ACOUSTICAL PERFORMANCE TEST REPORT

ASTM E90 AND ASTM E492 TESTING ON  
FALQUON GMBH 5 MM SPC WITH 1 MM XPS UNDERLAYMENT

203 mm Concrete Slab with Suspended Ceiling

L8528.01-113-11-R0

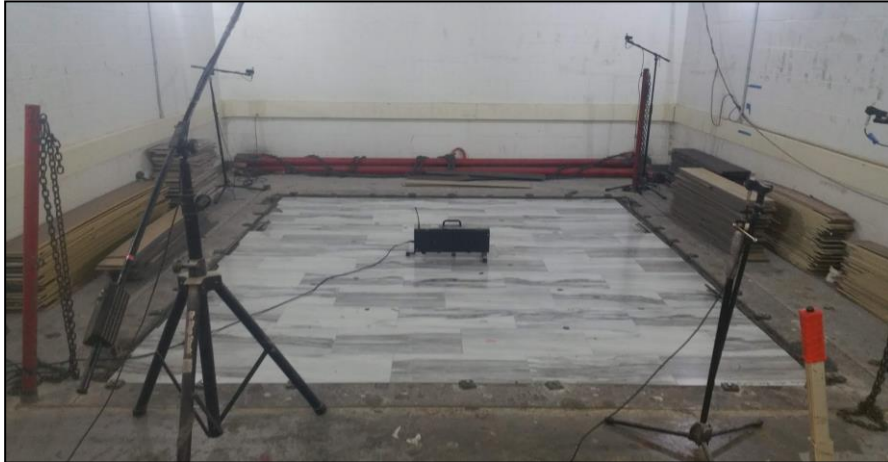
Photo No. 1

Source Room View of Test Specimen Installation

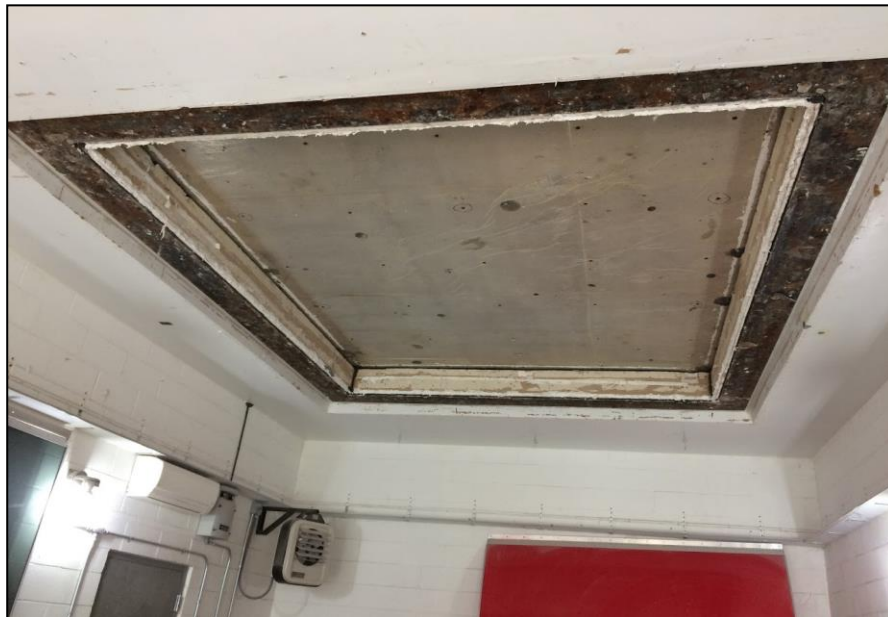
Photo No. 2

Receive Room View of Test Specimen Installation
